# Regeneration of an Osseous Peri-Implantitis Lesion

**ABSTRACT:** This case report concerns the loss of osseous tissue around two hydroxyapatite (HA) Biovent implants, placed in 1993, at sites #30 and #31. The implant in site #31 was positioned with a distal angle, resulting in an ill-fitting prosthesis. This permitted bacterial colonization to set up a peri-implantitis. The rough HA coating on the implants further exacerbated the resultant bone loss. In an attempt to rectify the pathology, surgical debridement, antibiotic therapy, bone grafting, and guided tissue regeneration with a barrier membrane were utilized. This case report documents a successful partial repair of osseous housing around these implants.

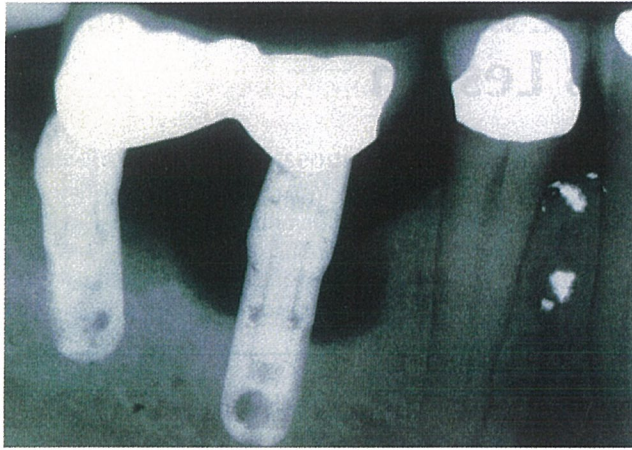
**Fig. 1.** Note 50% bone loss around the fixtures at sites #30 and #31.

Education Clinic complaining of a loose bridge that was placed on implants in the mandibular right side, at sites #30 and #31. Her medical history was noncontributory. Radiographic examination revealed 50% bone loss around the two fixtures at sites #30 and #31 (Figure 1). An oral surgeon had placed these fixtures 3 years previously.

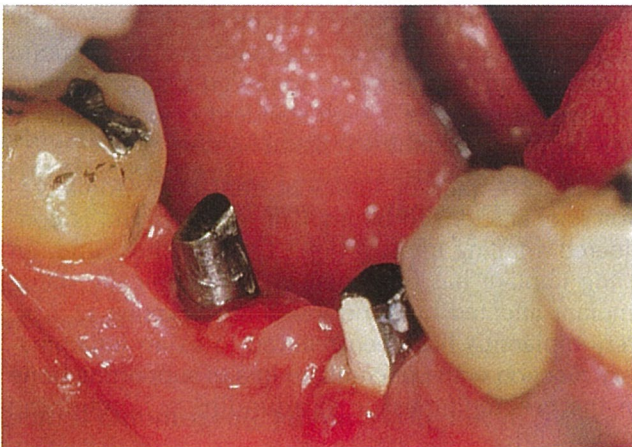
**Fig. 2.** Clinical presentation of the two fixtures, demonstrating inflamed, edematous tissue.

The two connected crown were removed. The gingival tissue around the abutments appeared inflamed, exhibiting edema, bleeding upon palpation, and supuration (Figure 2). The surgeon and the restorative dentist were contacted regarding the prior surgical implant placement. Radiographs of the surgical placement and crown insertion were provided (Figure 3).

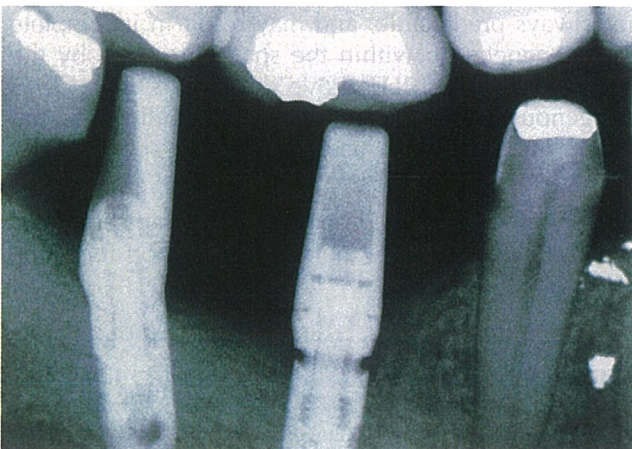
**Fig. 3.** Radiograph from the initial restorative dentist.

The implant in position #31 was distally placed. Radiographic examination revealed the closeness of the mandibular canal to the implant site. The two implants were of standard diameter and coated with hydroxyapatite (Biovent-Paragon, Encino, CA). They were not aligned and were placed in a non-parallel direction. The crown and the abutment appeared ill fitting. This may have led to the creation of a bacterial niche.

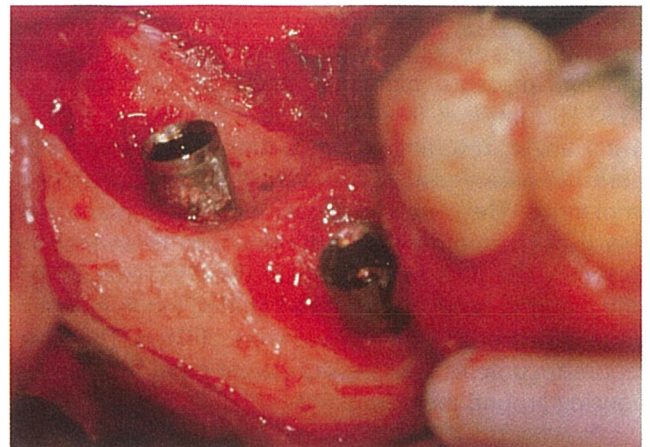
**Fig. 4.** Post-debridement photograph. Note crater-like osseous defect.

A full-thickness flap was elevated and debridement of the granulation tissue was performed. The osseous defects around the two implants both exhibited crater shapes (Figure 4). The implant surface was treated with rotary instruments and citric acid was applied for 37 seconds. The two defects were filled with irradiated freeze-dried cancellous bone, 500 mesh (DFBD-US Red Cross Bone Bank, Washington DC) (Figure 5). The area was then covered with an Epi-Guide (Epiguide-Calcitek, San Diego, CA) membrane (Figure 6). The flap was sutured with 4.0 black-silk interrupted sutures (Figure 7). The patient was placed on amoxicillin 500 mg, 1 tid for 10 days.

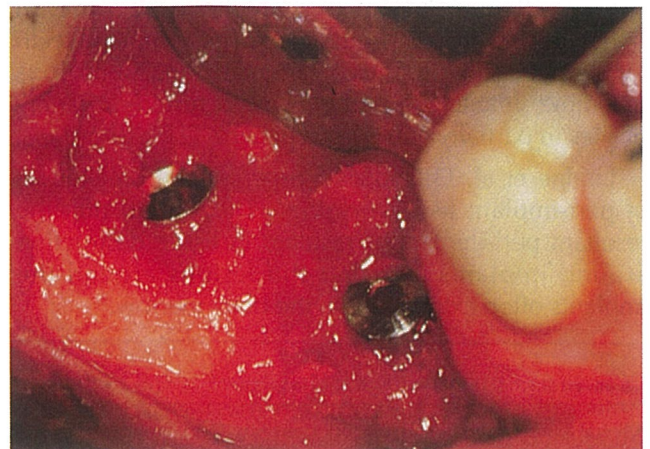
**Fig. 5.** Cancellous bone placed in the osseous defect.

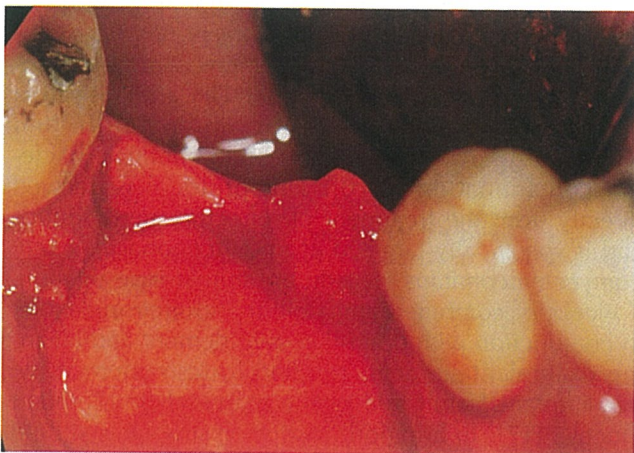
**Fig. 6.** Epi-guide layered over the graft.

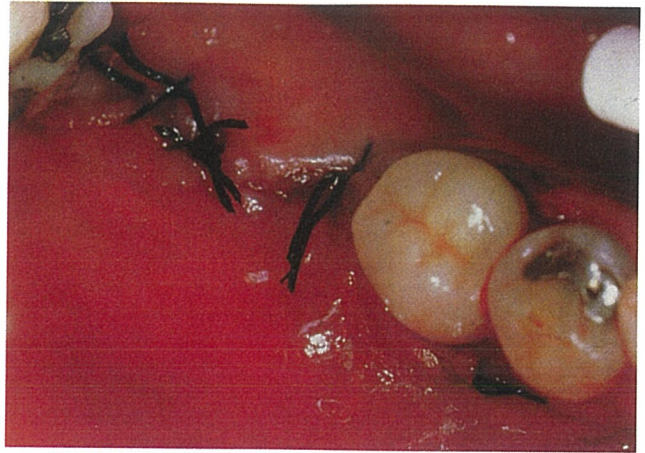
**Fig. 7.** Flap sutured in place.

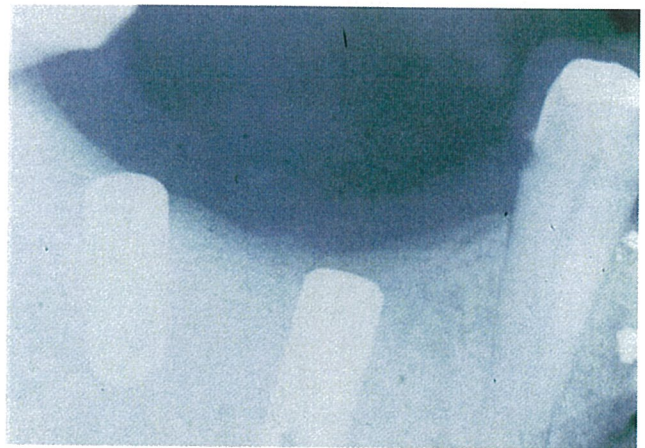
**Fig. 8.** Radiograph demonstrating healing after 6 months.

After 6 months, a second-stage procedure was performed. At this time, tooth #32 was removed to allow a proper path of insertion, and a periodontally maintainable anatomy. There appeared to be clinical and radiographic bone fill around the implants (Figures 8–11). A provisional prosthesis was placed on the implants (30 and 31) for a 2-month period. The final prosthesis was made of porcelain fused to metal and

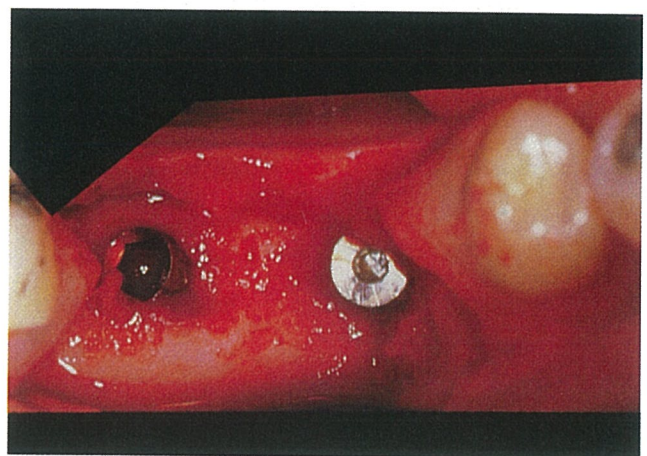
**Fig. 9.** Photograph suggesting clinical bone fill.

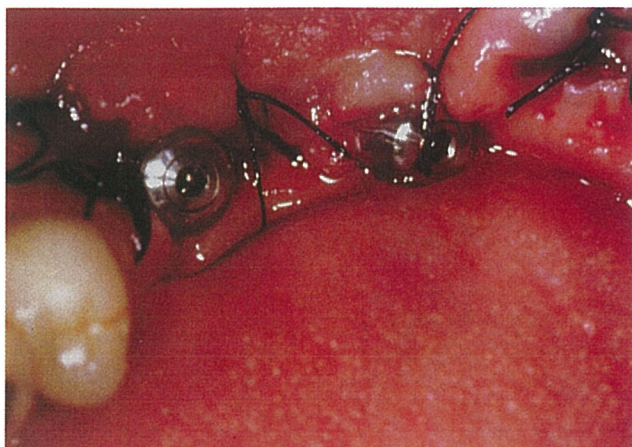
**Fig. 10.** Following extraction of #32 and placement of healing abutments.

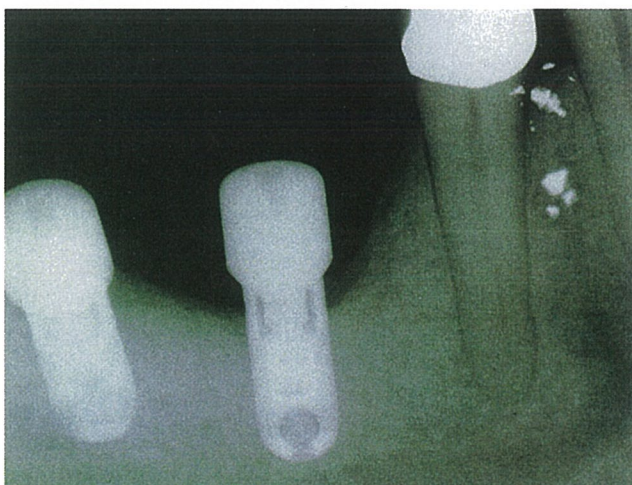
**Fig. 11.** Radiograph of healing abutments in place.

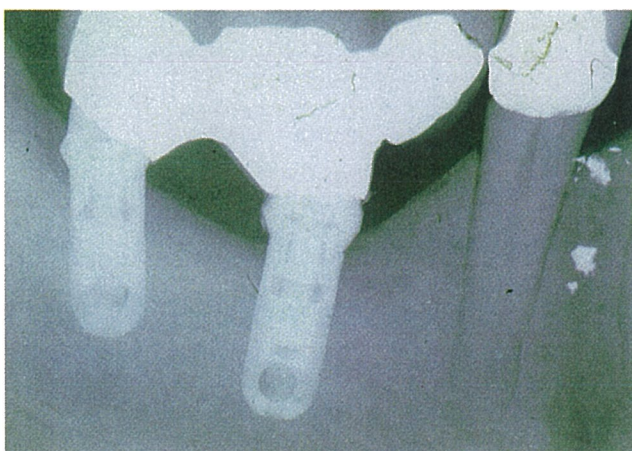
**Fig. 12.** Radiograph of the final bridge in place.

was inserted at New York University College of Dentistry (Figures 12 and 13).

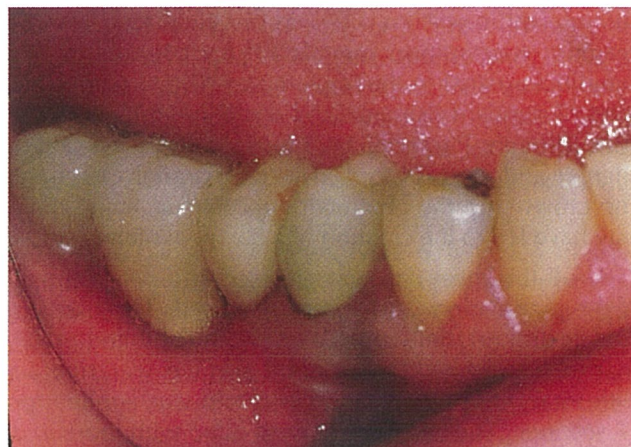
**Fig. 13.** Clinical slide of permanent bridge in place.
